Case: Tooth fracture repair with Anterior Composite Buildup

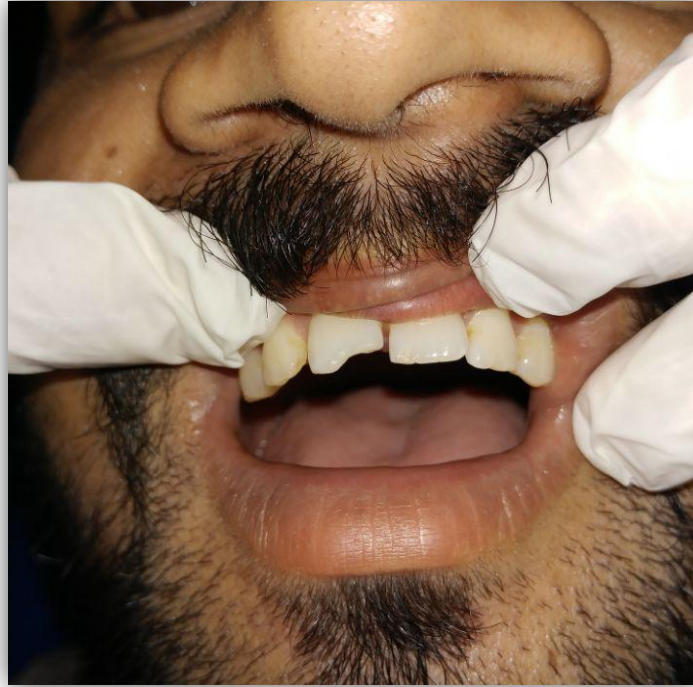
Figure 1: Upper Right 1 fracture

On examination there was visible loss of enamel and dentine with no soft tissue injuries and no visible sign of pulp exposure. Tooth was not tender to percussion. On pulp vitality test pulp was vital. If the tooth was tender to percussion I would check for possible luxation or root fracture injury. There was no mobility.

Therefore I went ahead with the provisional treatment plan by lining the exposed dentine with glass ionomer cement followed by etching the tooth with 37% phosphoric acid for 30 sec and rinse and dry the tooth, finally application of bonding agent and buildup with composite.

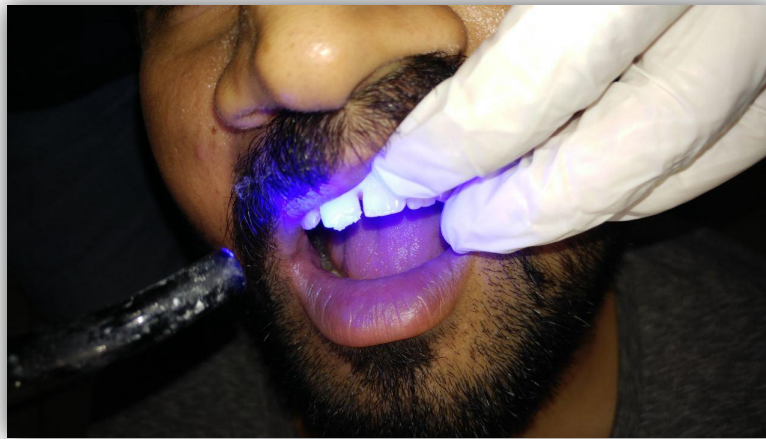
Figure 2: Application of Composite and Curing

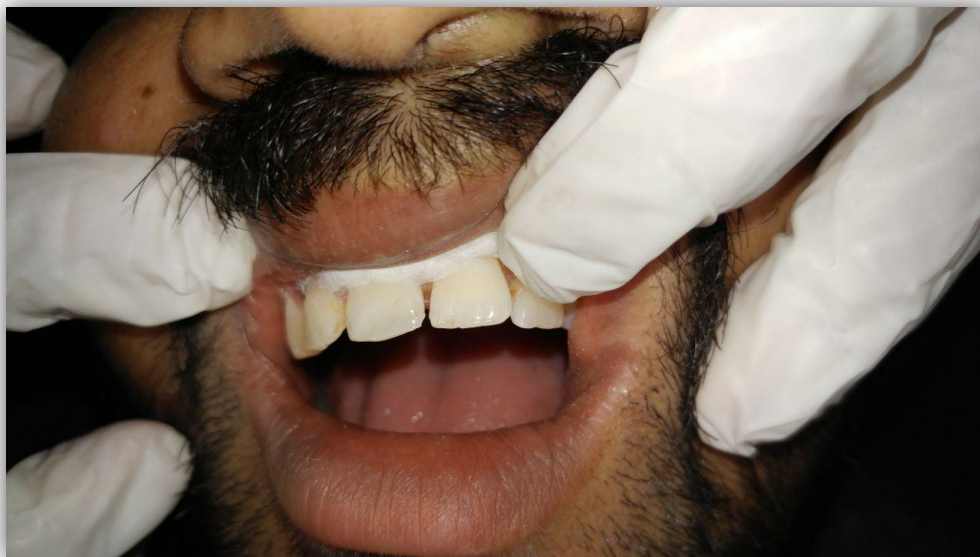
The patient recovered well with satisfaction of his aesthetic dental appearance.

Figure 3: Aesthetically pleasing end result
